Debris/Ice/TPS Assessment And Photographic Analysis For Shuttle Mission STS-38

February 1991

DEBRIS/ICE/TPS ASSESSMENT
AND
PHOTOGRAPHIC ANALYSIS
OF
SHUTTLE MISSION STS-38

November 15, 1990

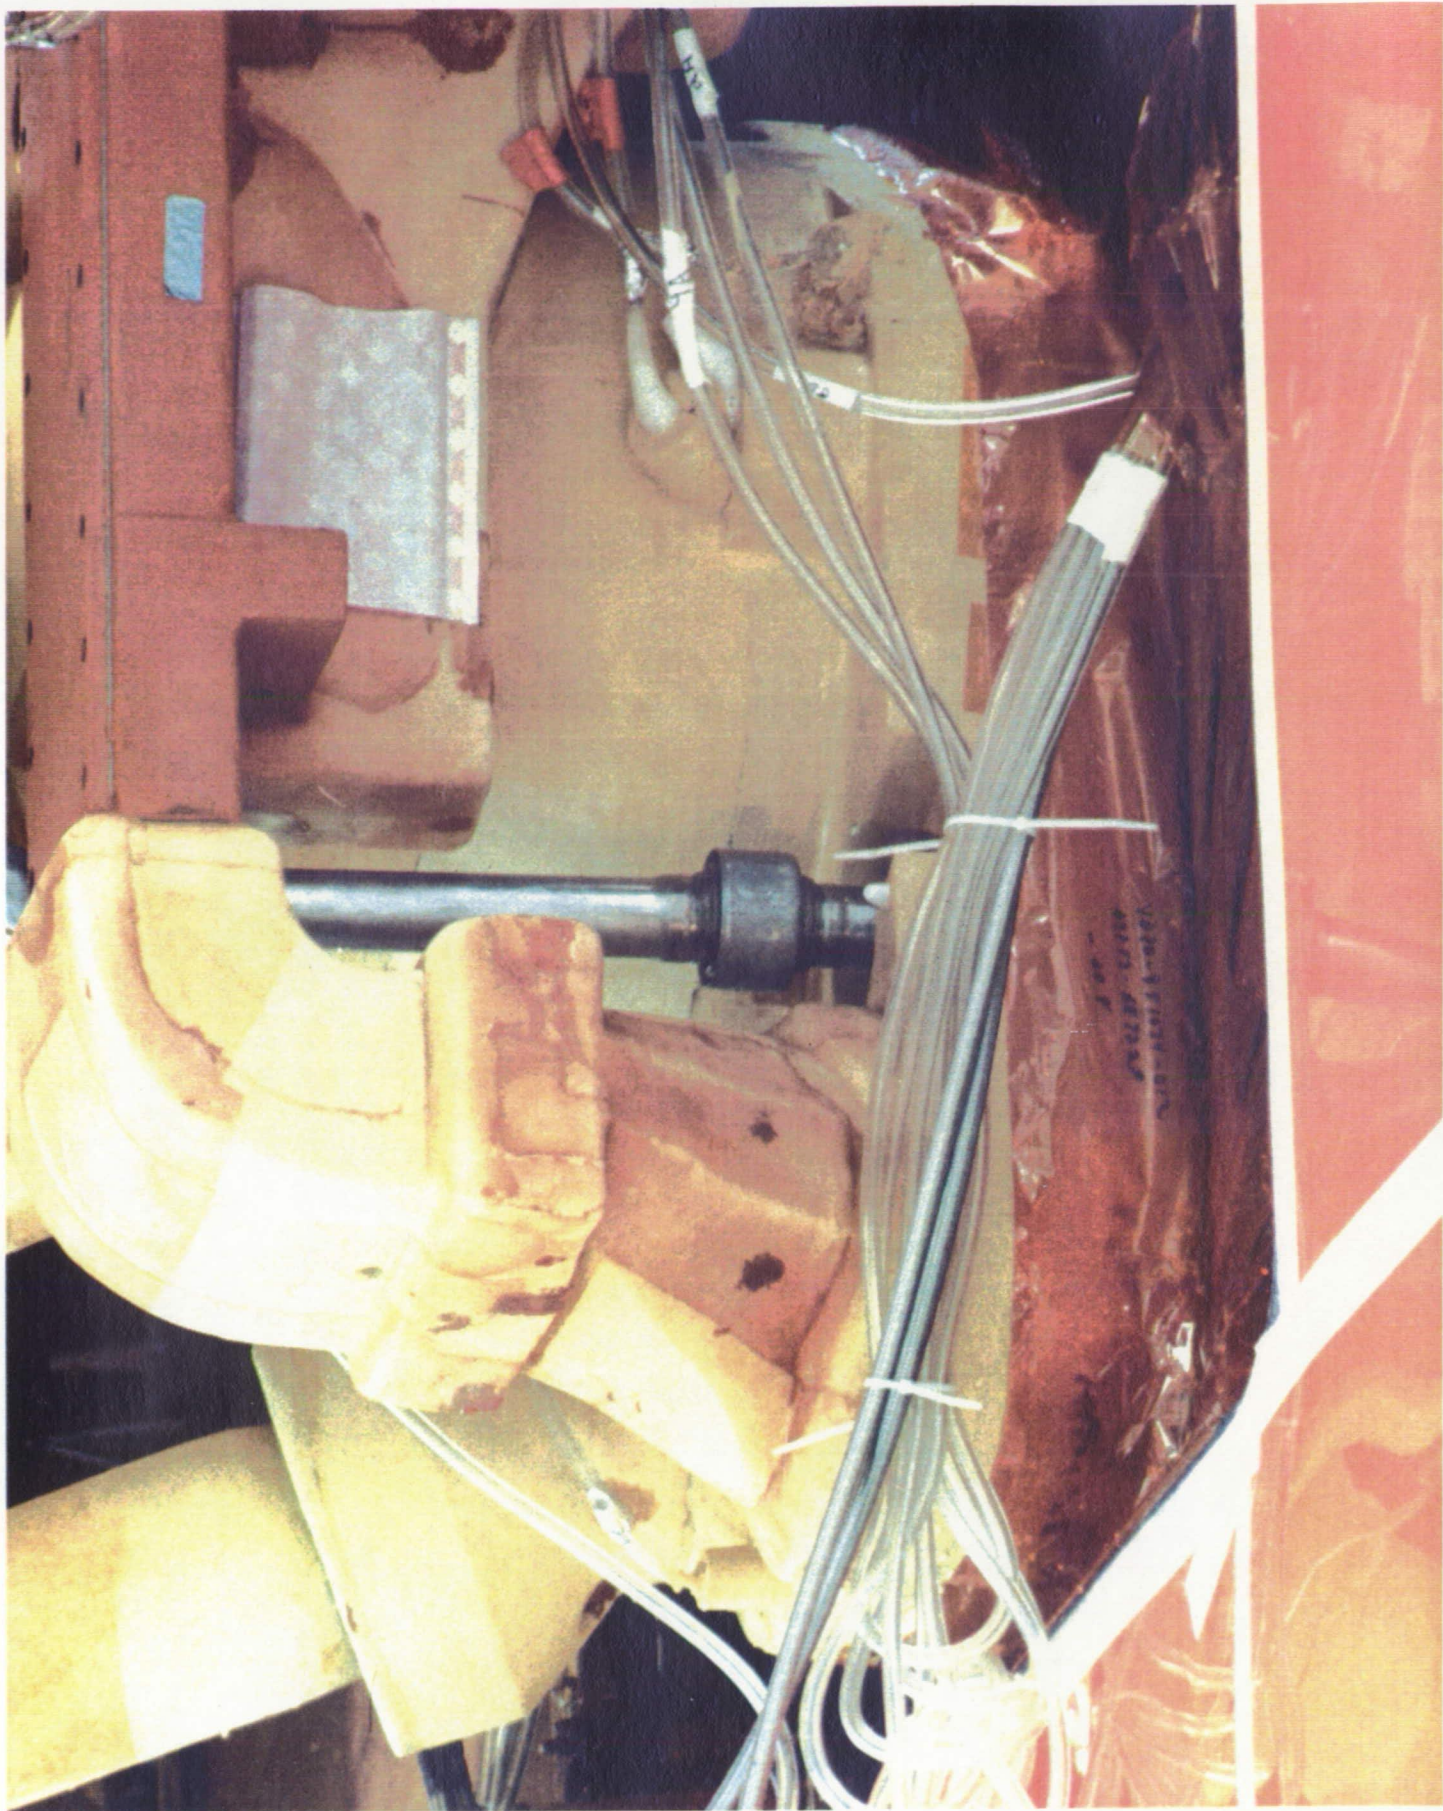
Post drain condition of the LH2 umbilical after Tanking Test 1.
Tygon tubes for sensing hydrogen leakage were positioned at
critical areas, such as plate gap and pyro canister purge vents

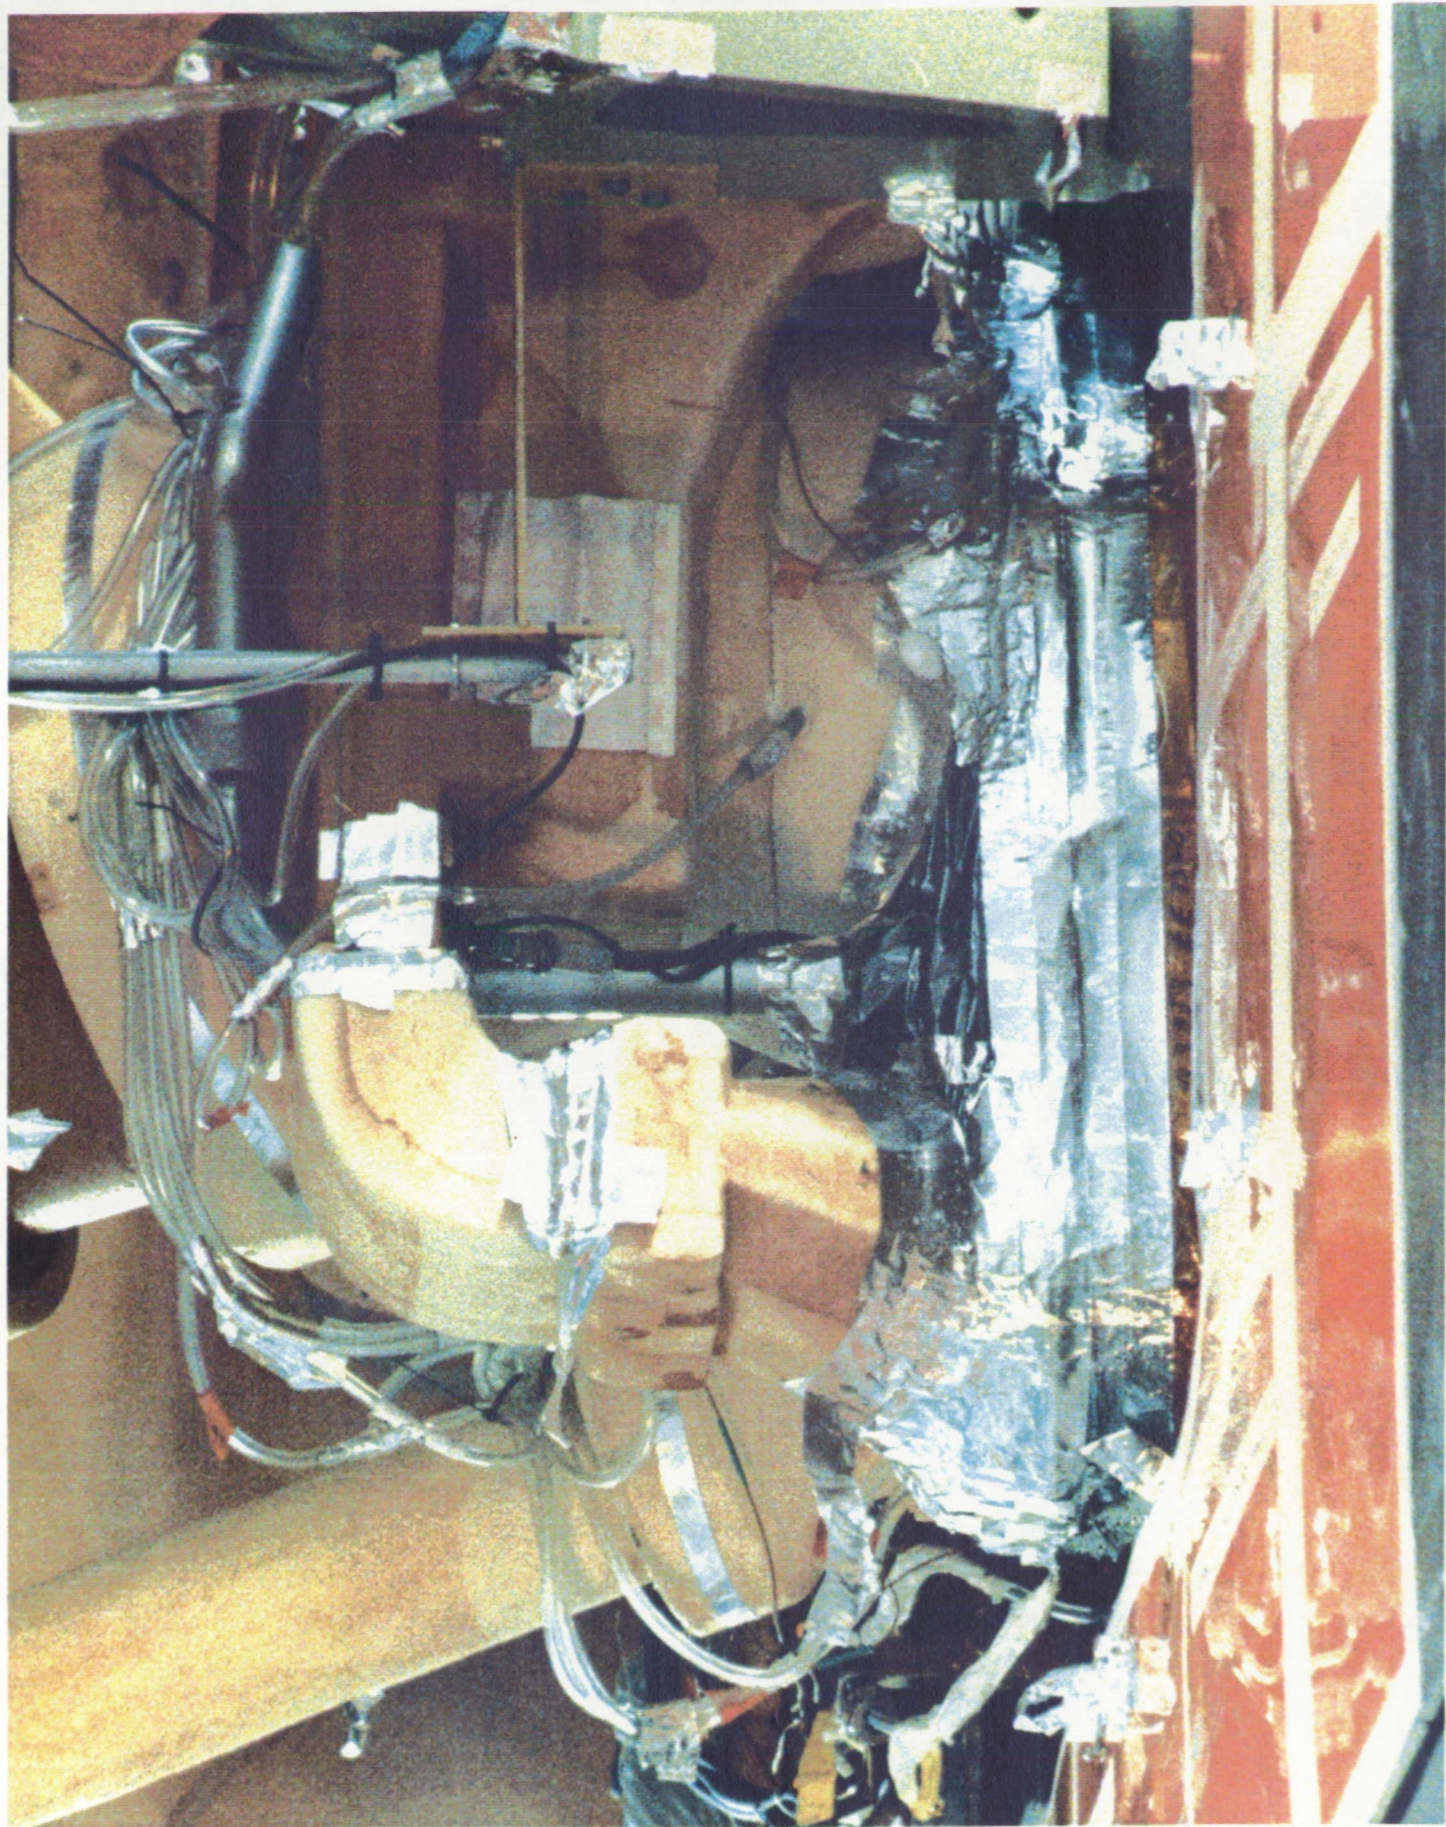
Post drain condition of the LH2 umbilical after Tanking Test 2.
Aluminum tape covers/seals in the area where the LH2 feedline
flange had been enclosed by a baggie to contain hydrogen leaks.

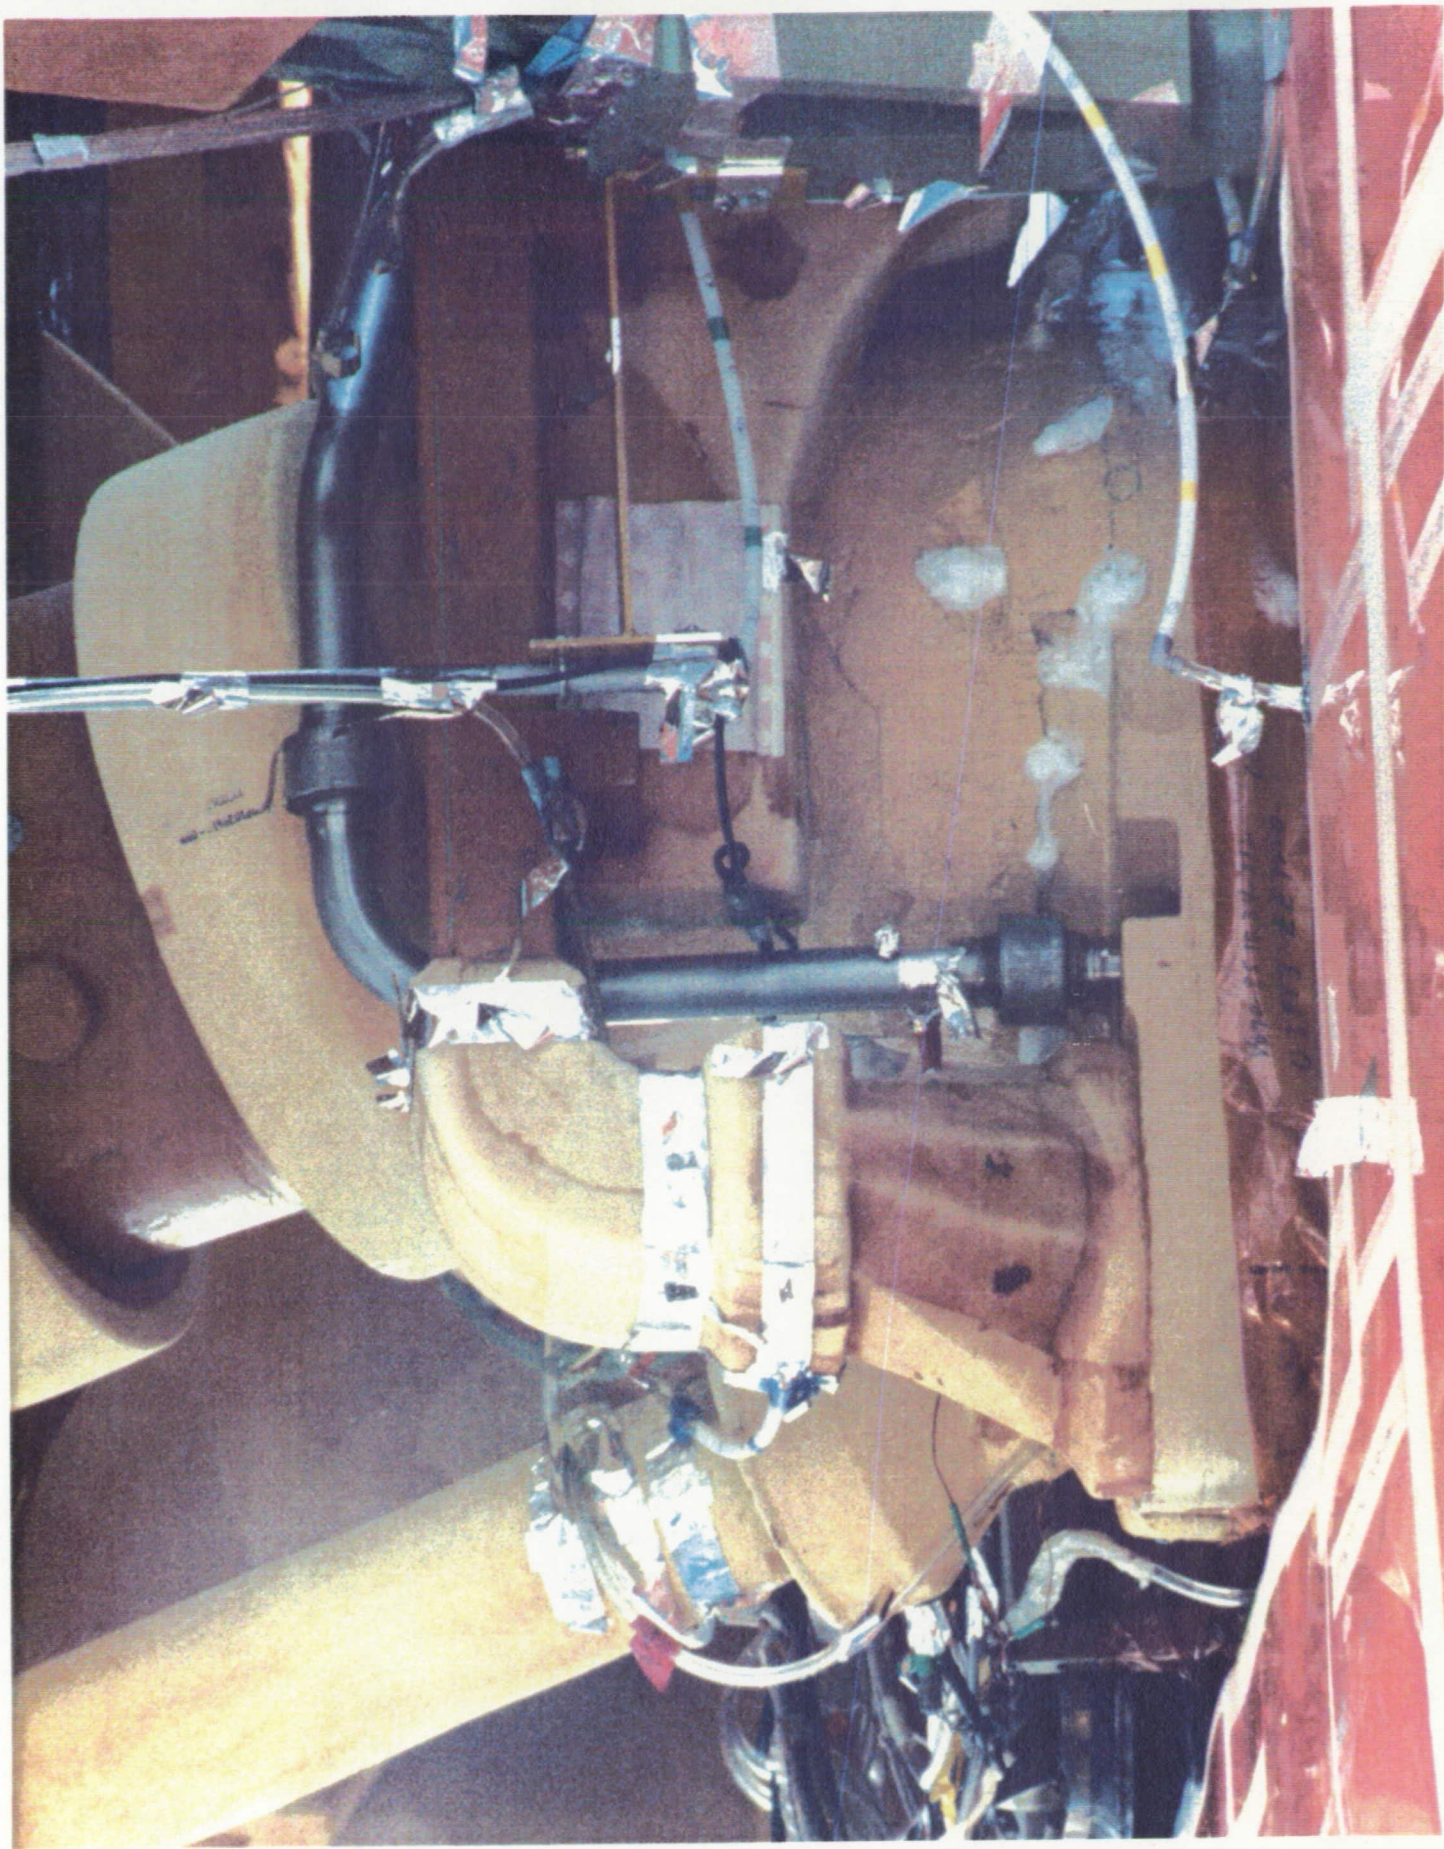
Post drain condition of the LH2 umbilical after Tanking Test 3. Special leak detection instrumentation, including tygon tube rakes, had been installed to map hydrogen leak flow fields.

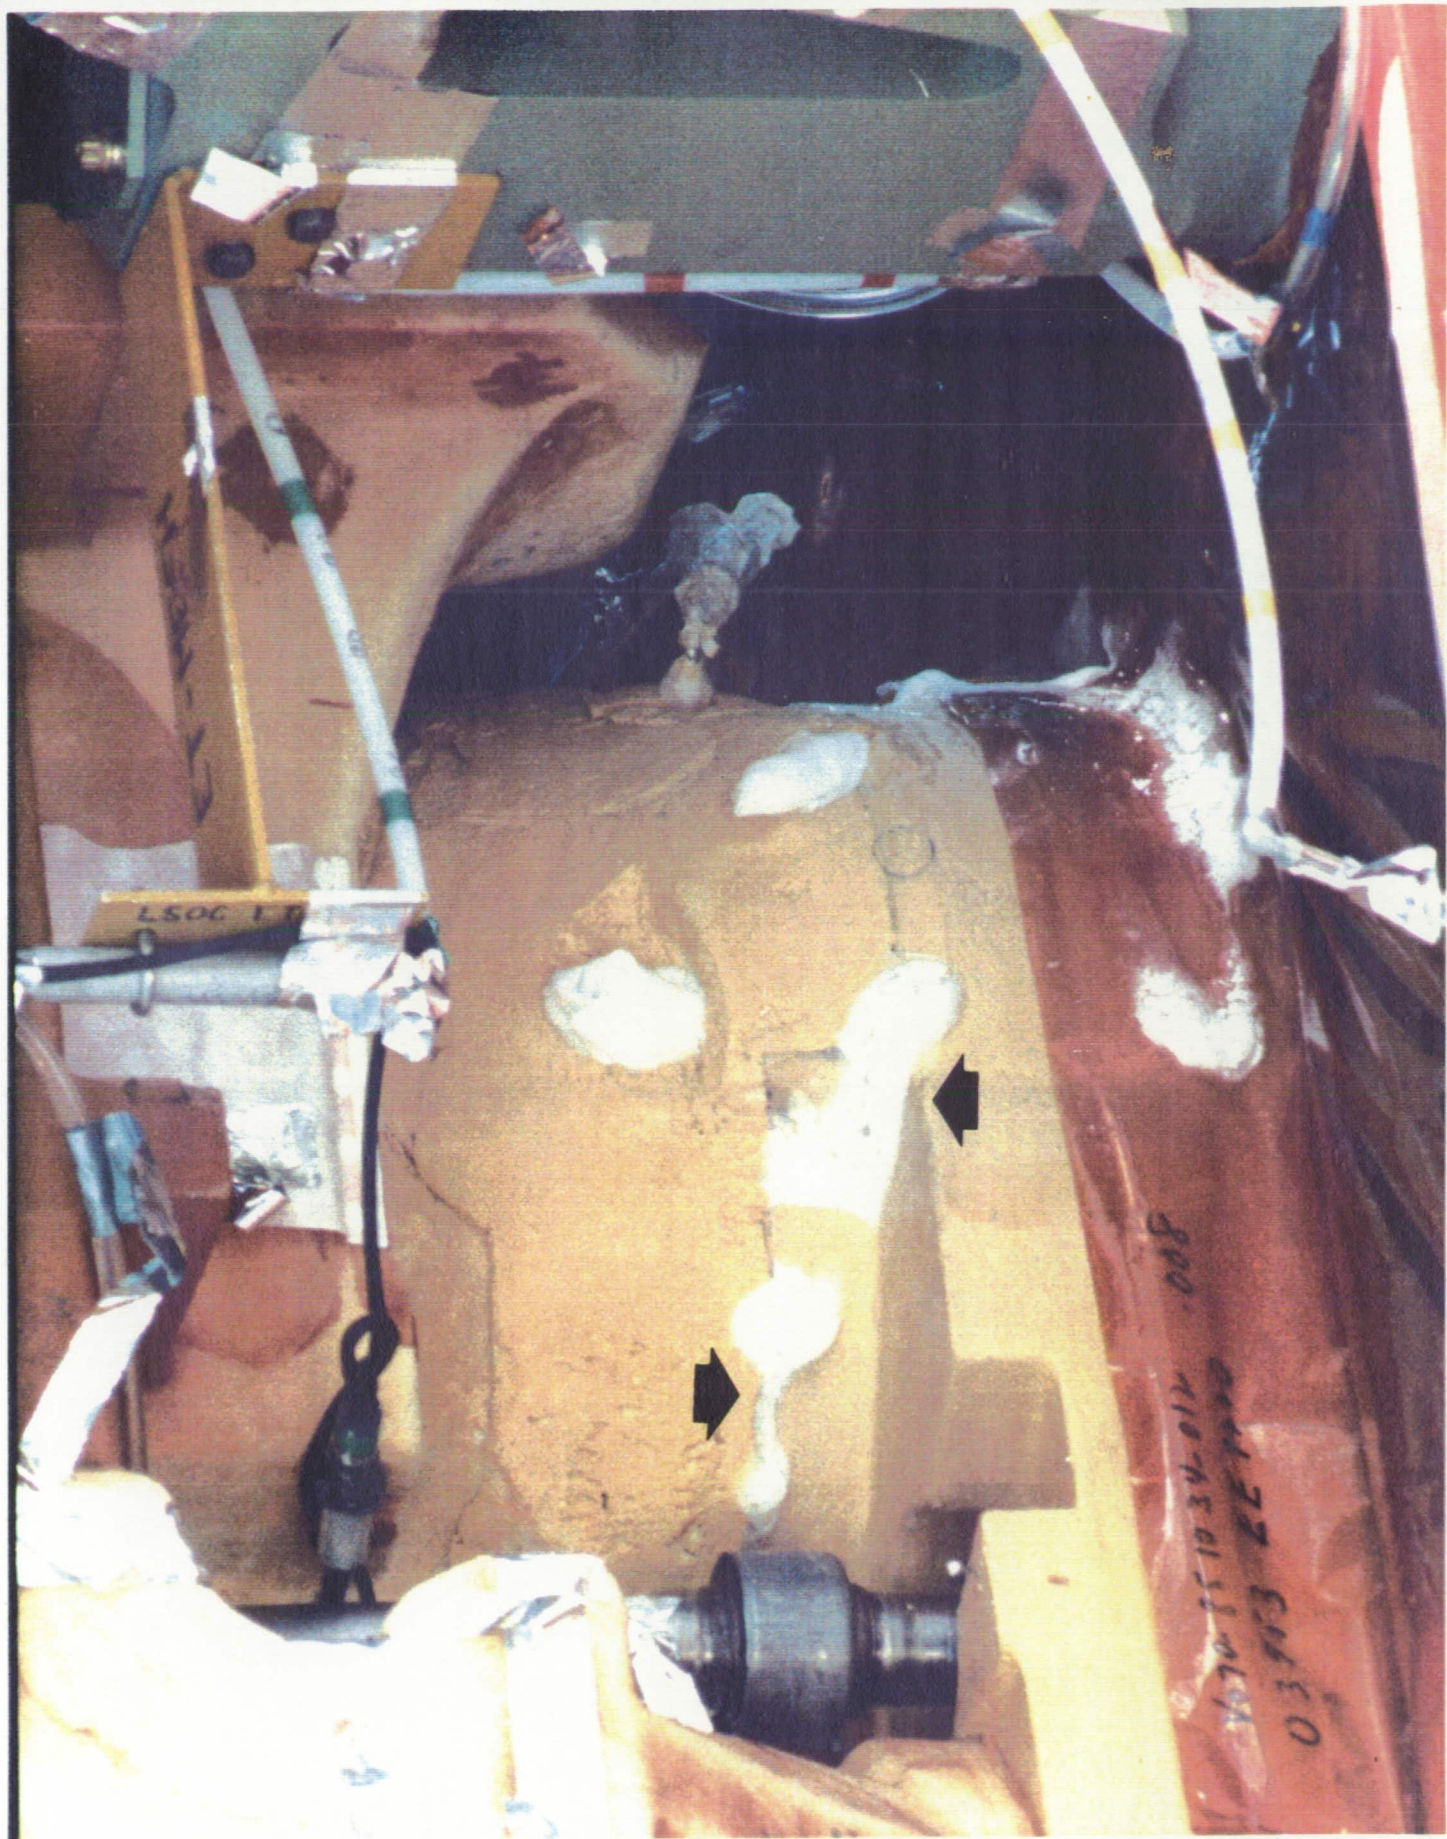
Due to the changing test configurations, numerous TPS cracks and isochem bondline thermal shorts were revealed by the appearance of ice/frost formations.

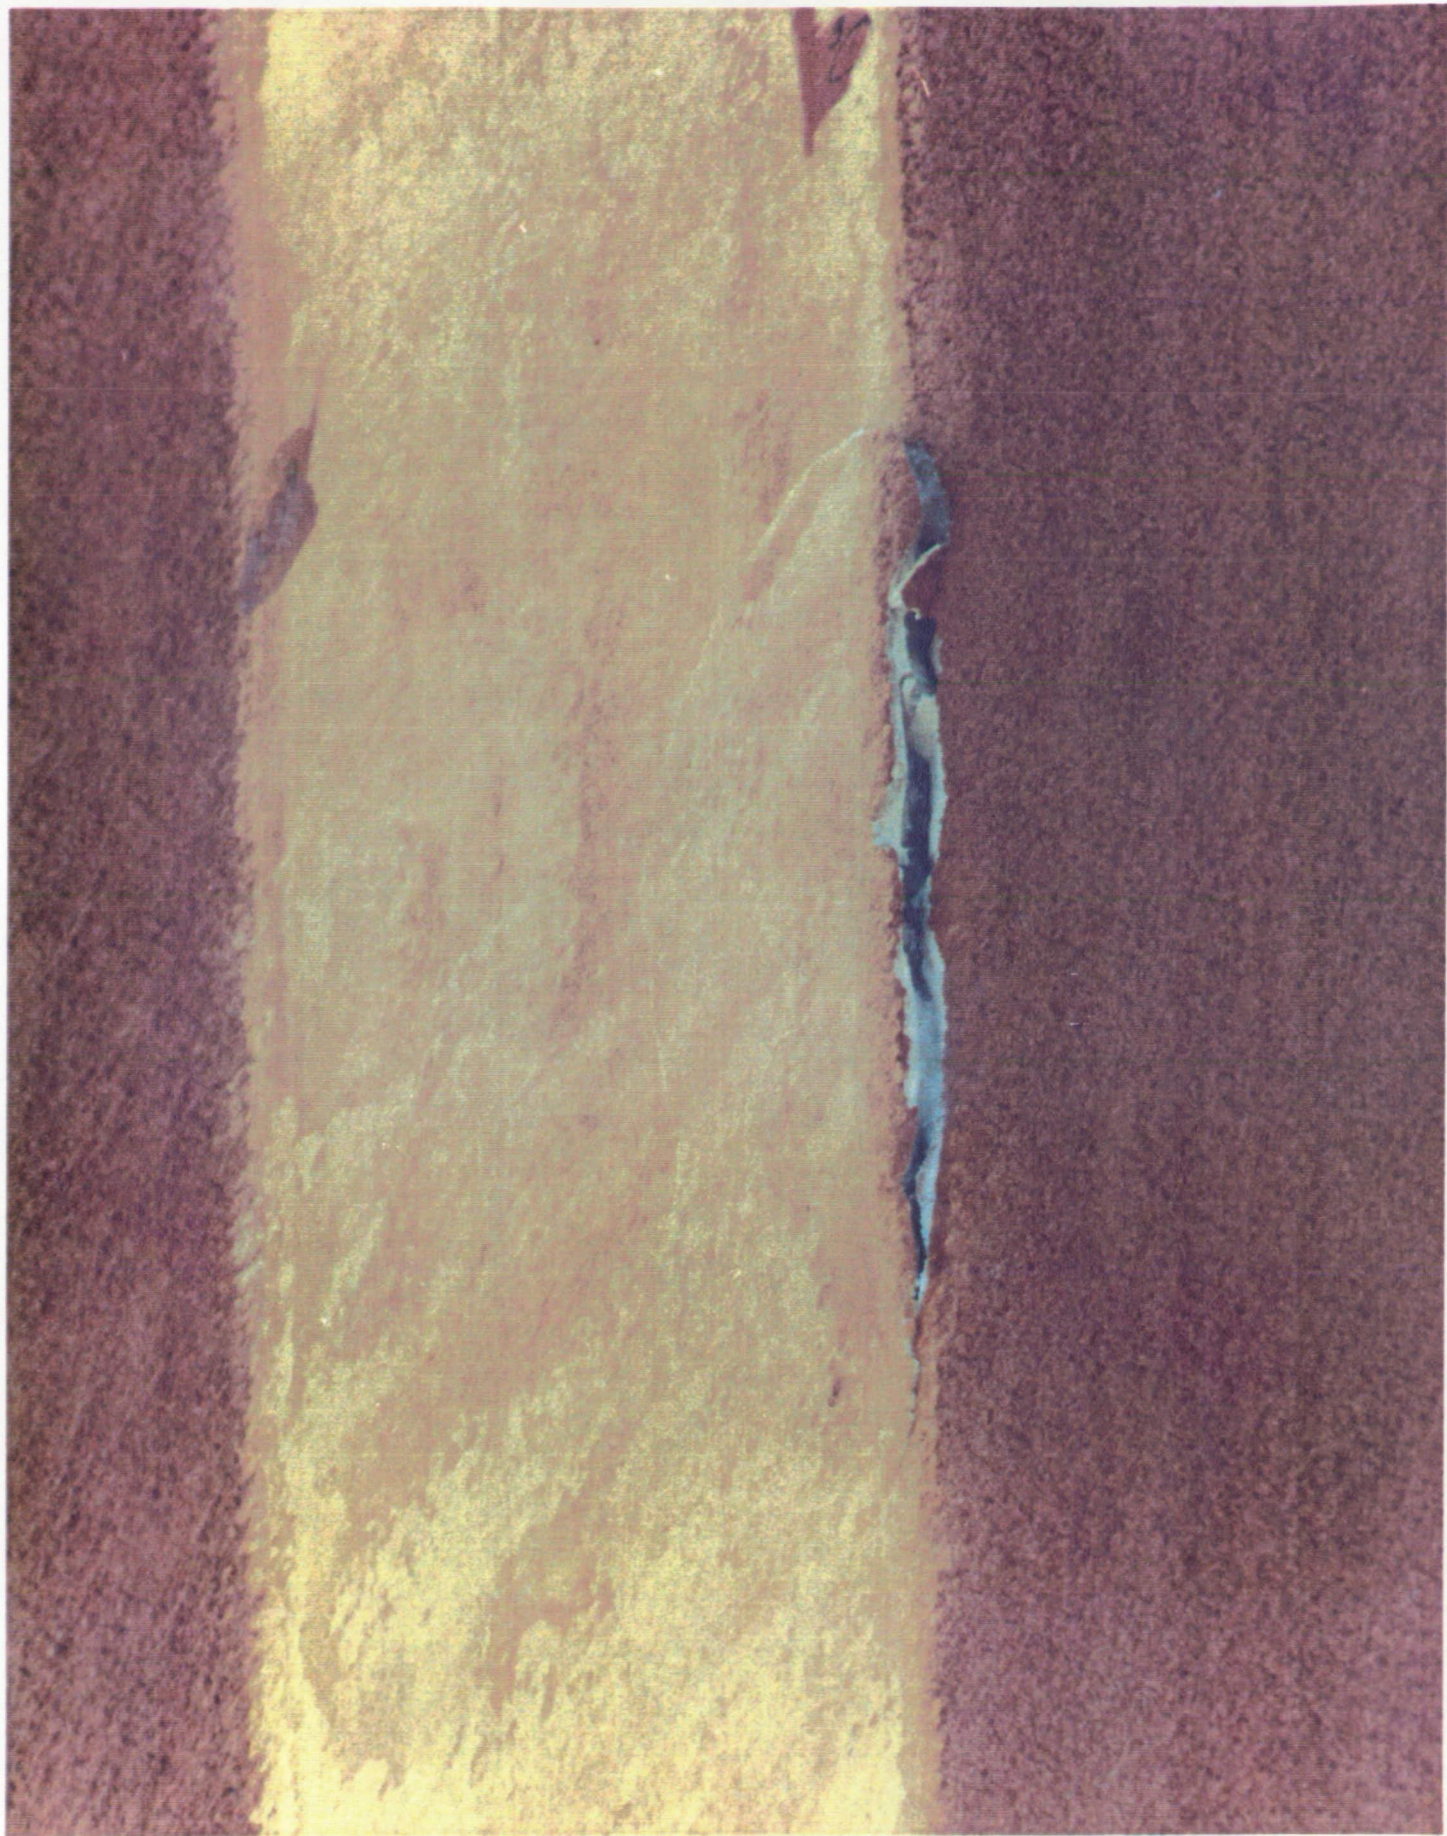
Tanking Test #3 post drain inspection revealed an 18-inch long crack 3/8-inch wide with offset on the aft hardpoint closeout.

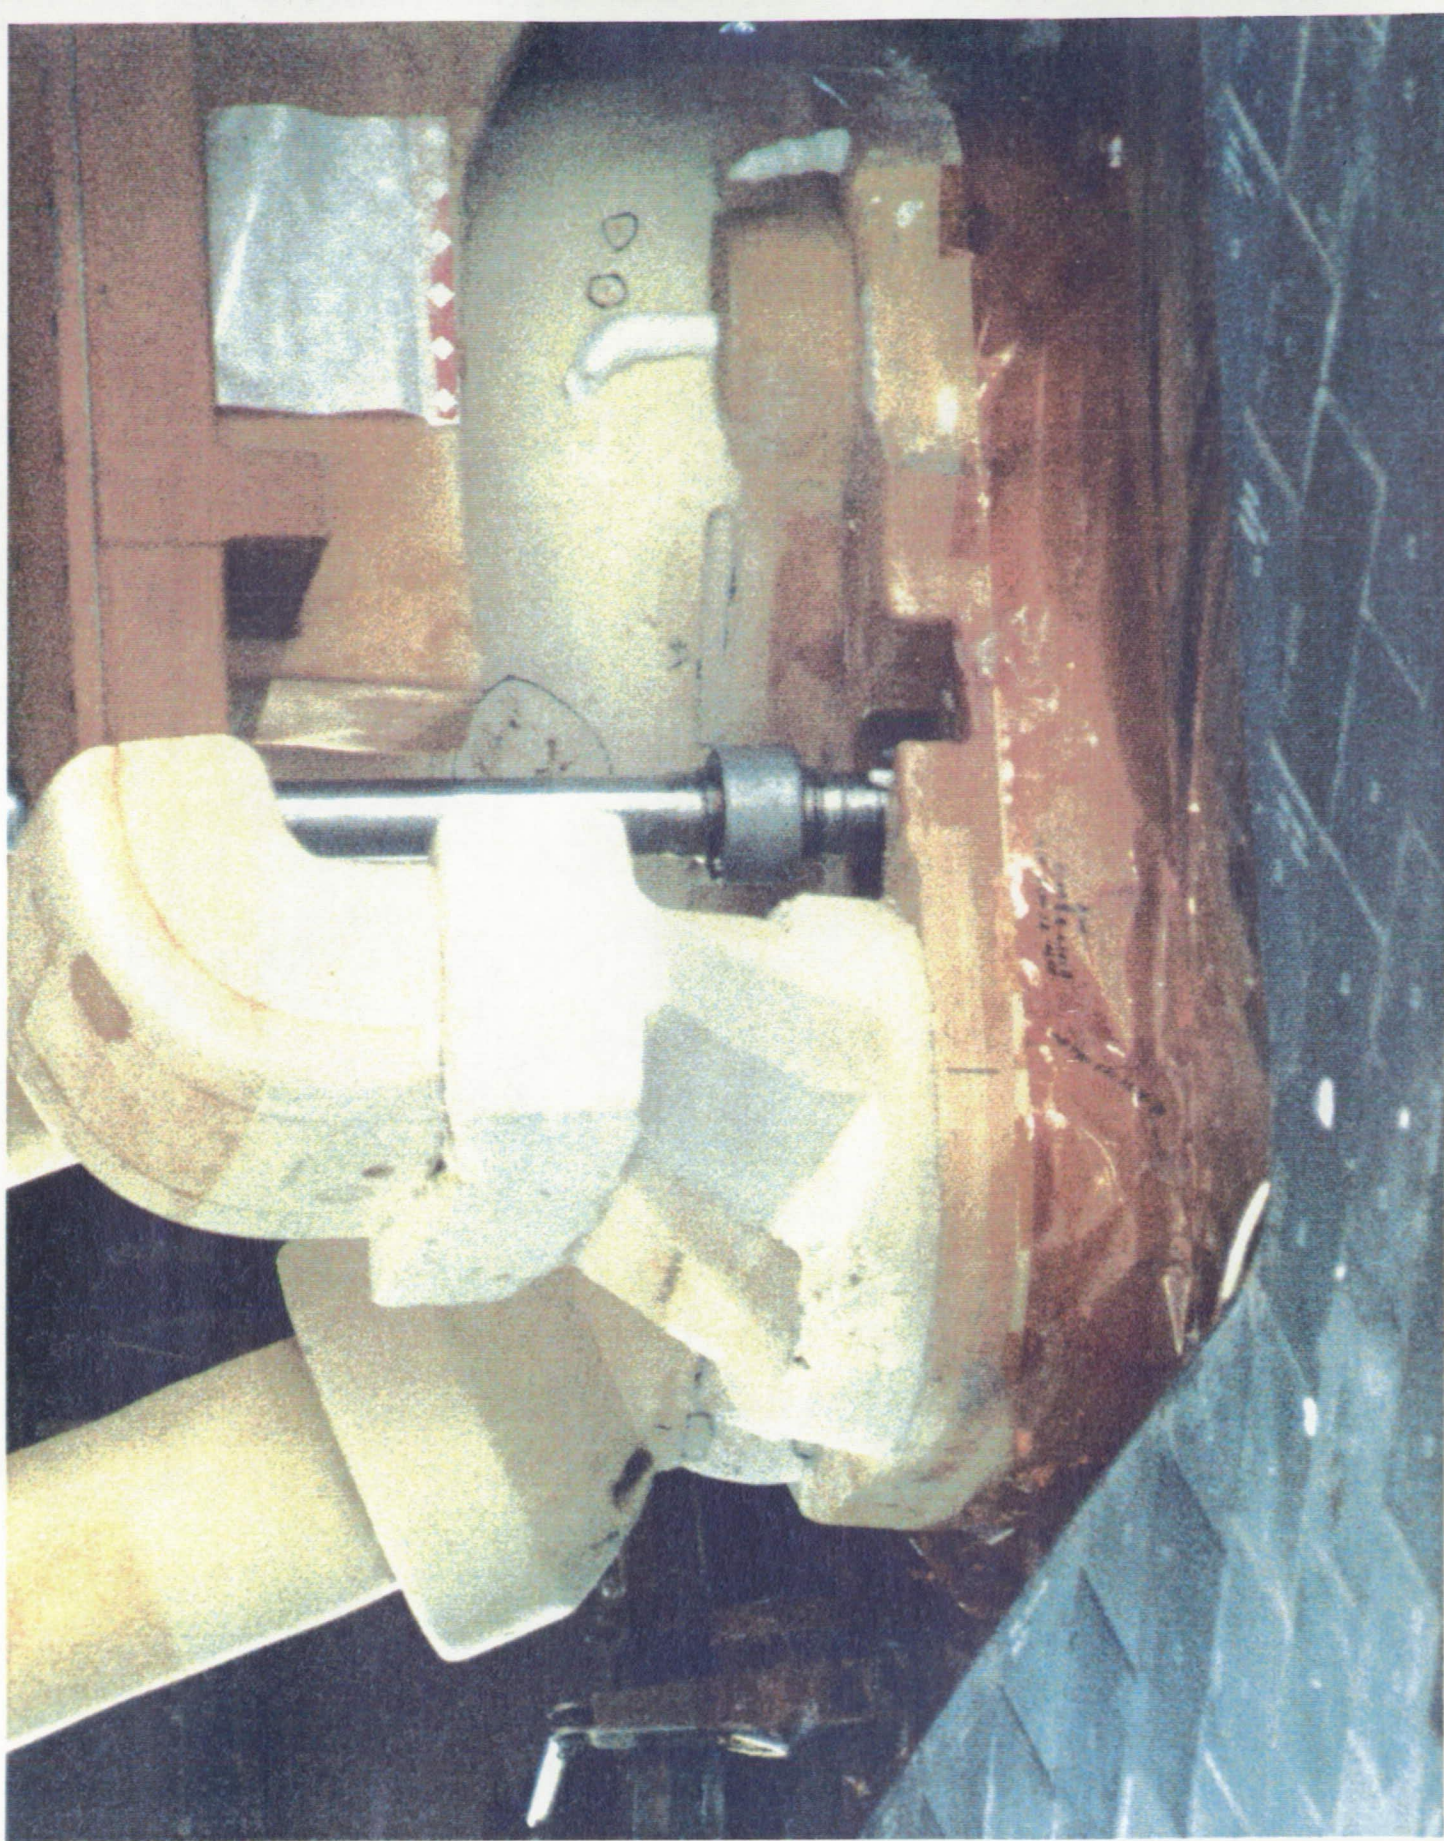
Post drain condition of the LH2 umbilical after Tanking Test 4.
Ice/frost formations on the plate gap and pyrotechnic canister
purge vents were normal.

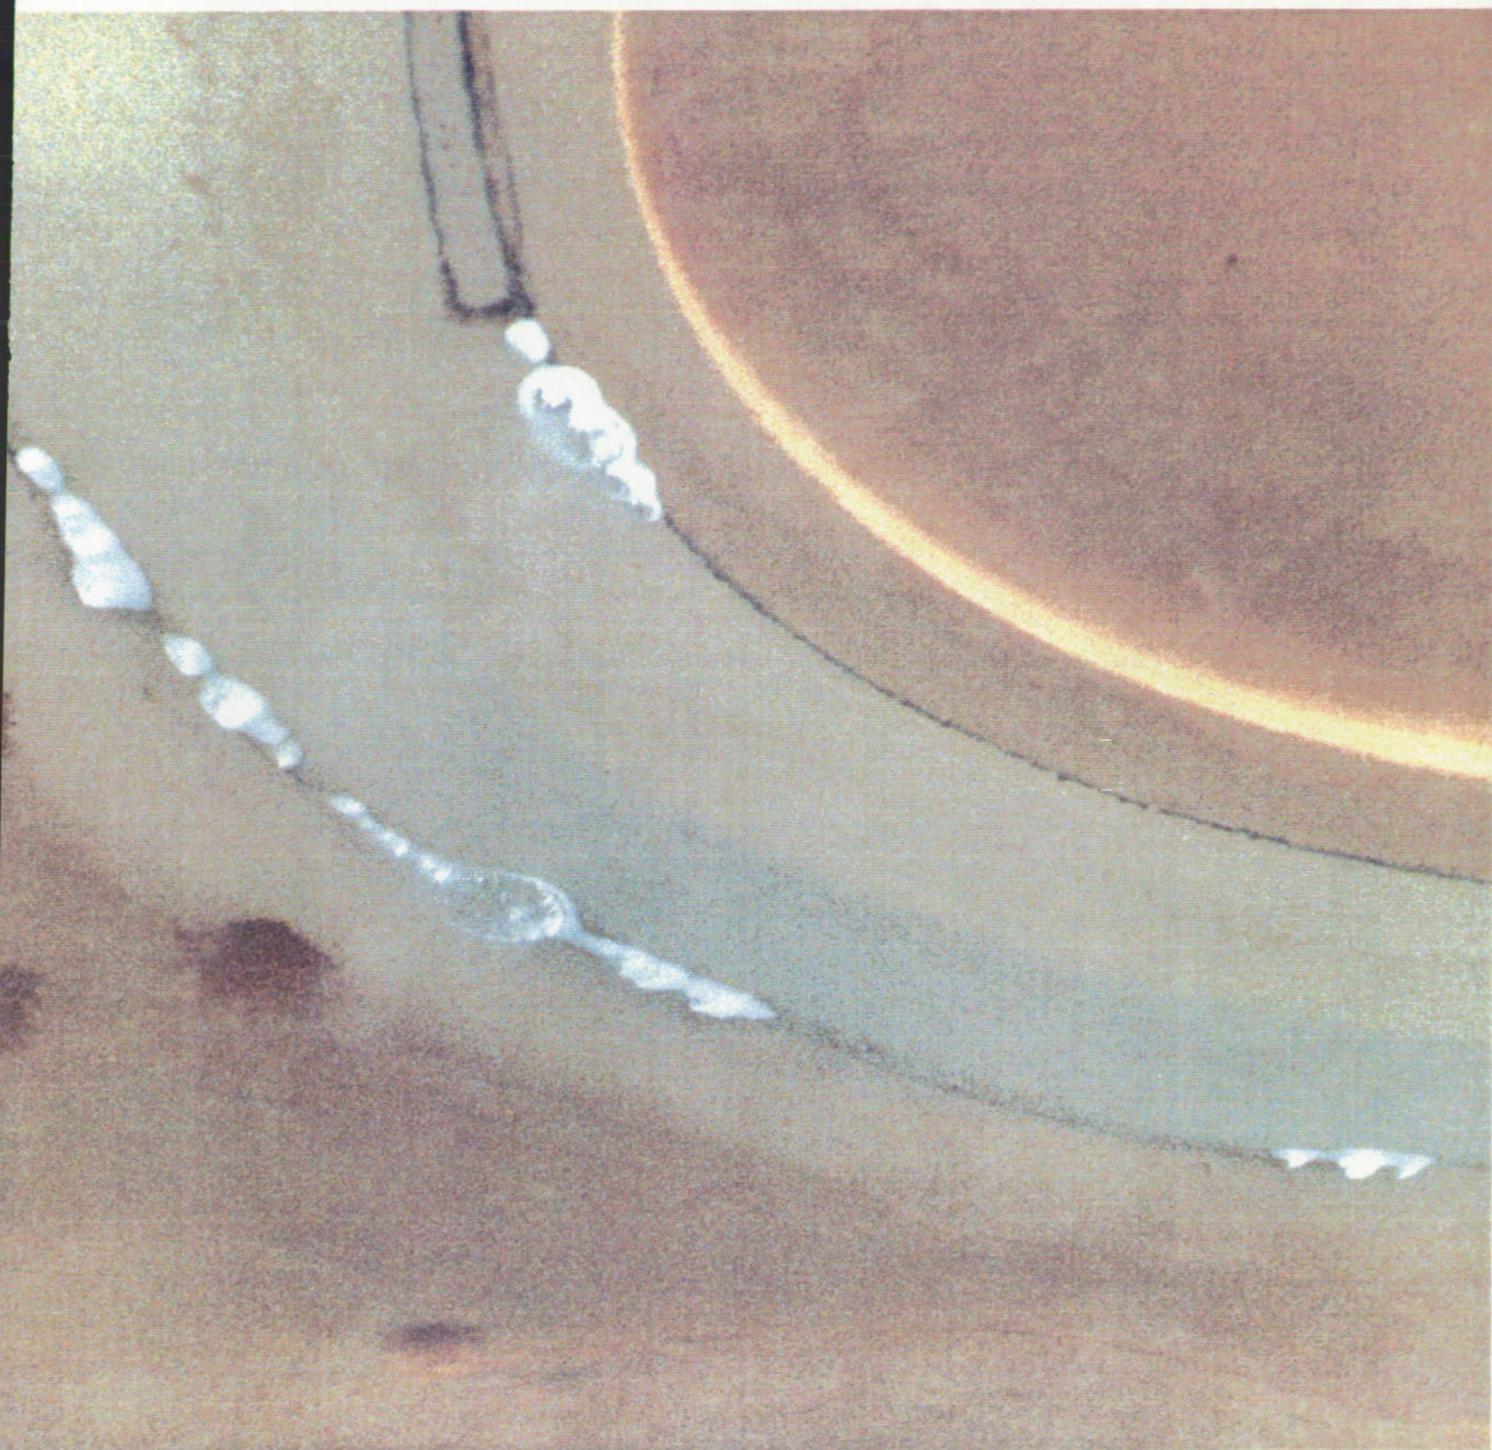
Ice/frost appeared on the outside bondline of the LH2 tank aft dome siphon manhole cover - approximately 40 percent of the circumference.

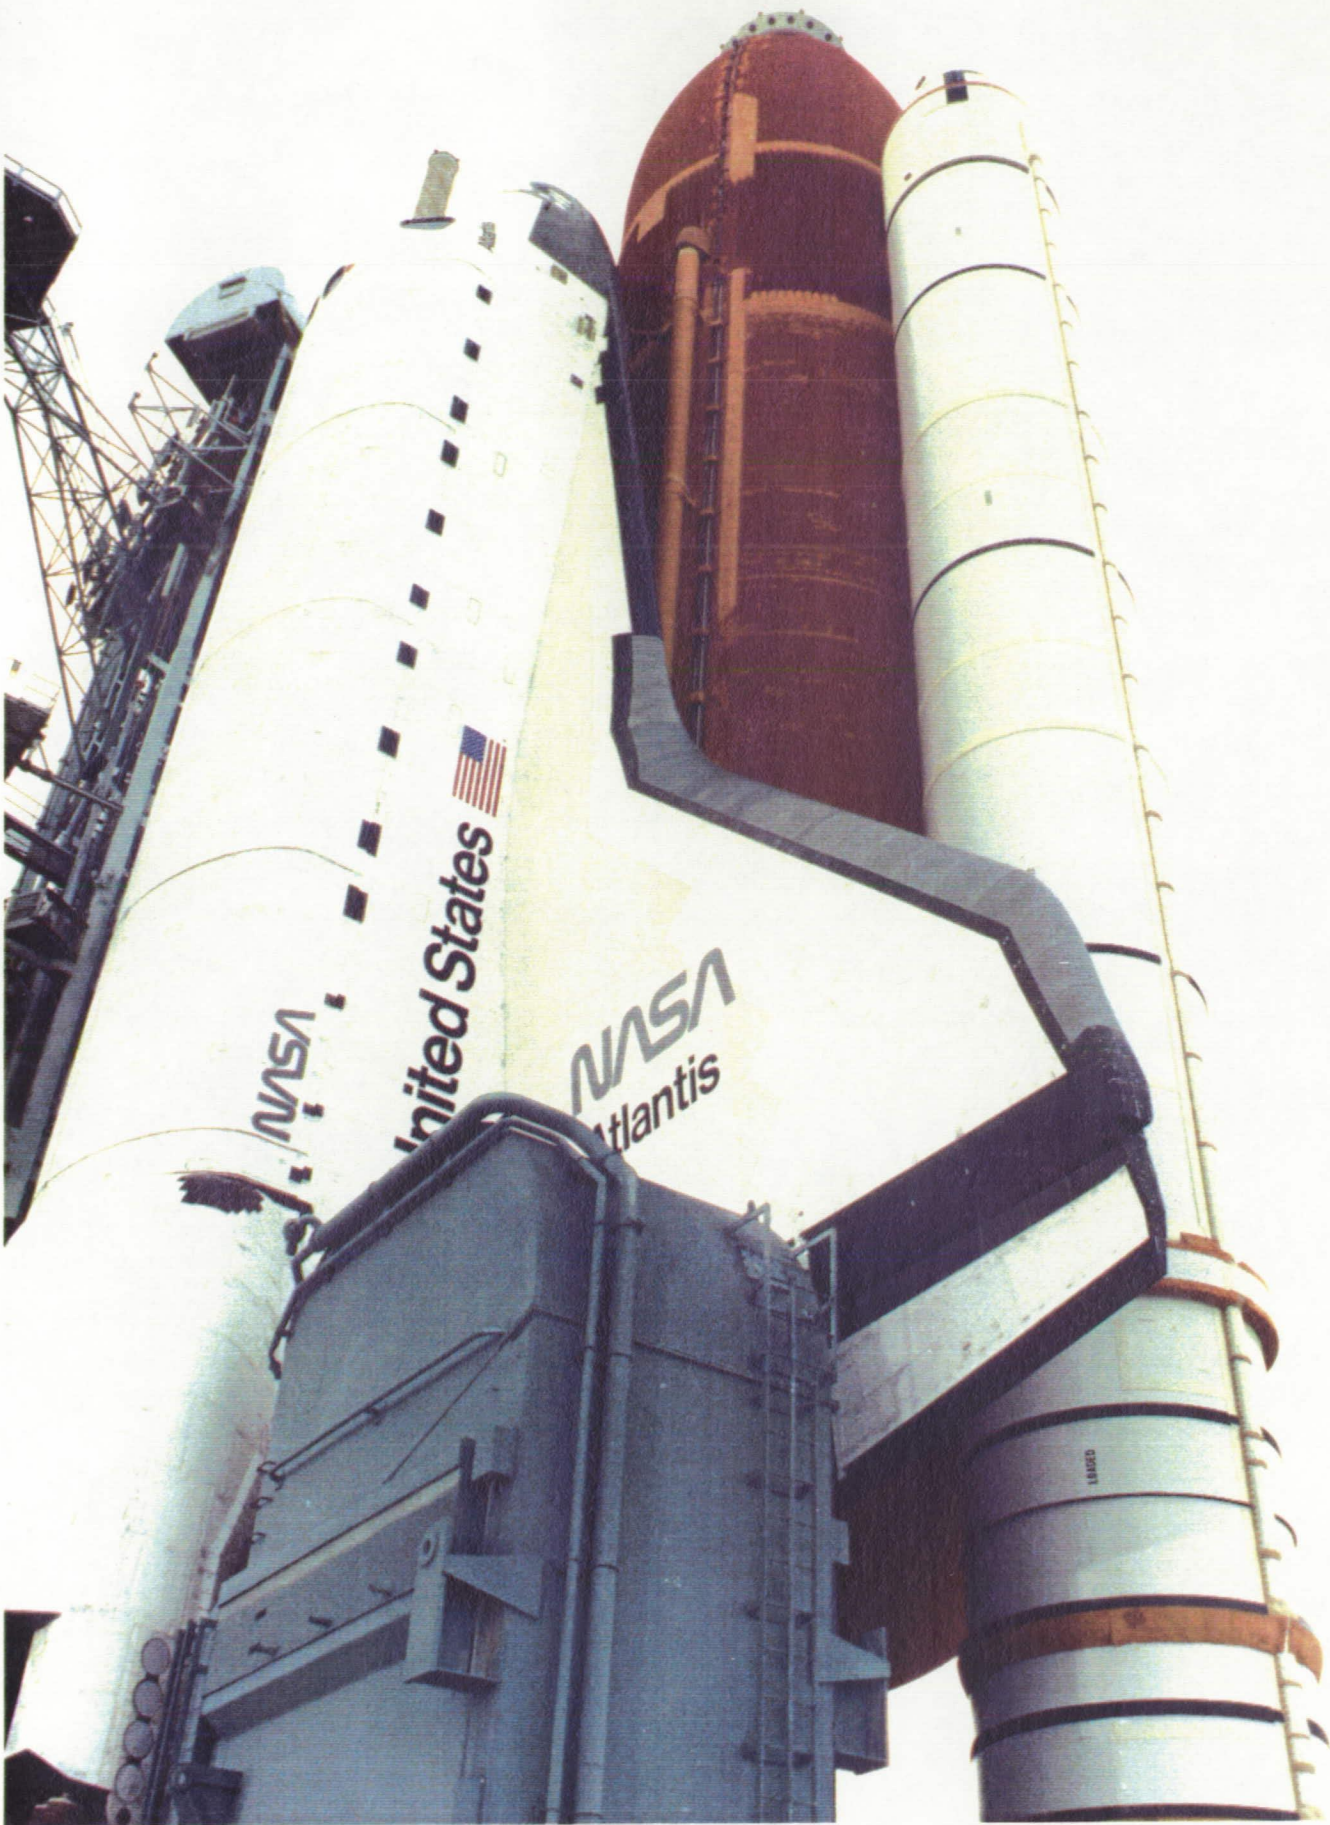
Overall view of OV-104, ET-40, and RH SRB BIO39. No ice/frost had formed on the External Tank TPS acreage.
